July 5, 2017

Re: Intel DQ77MK Motherboard Vulnerability Fix

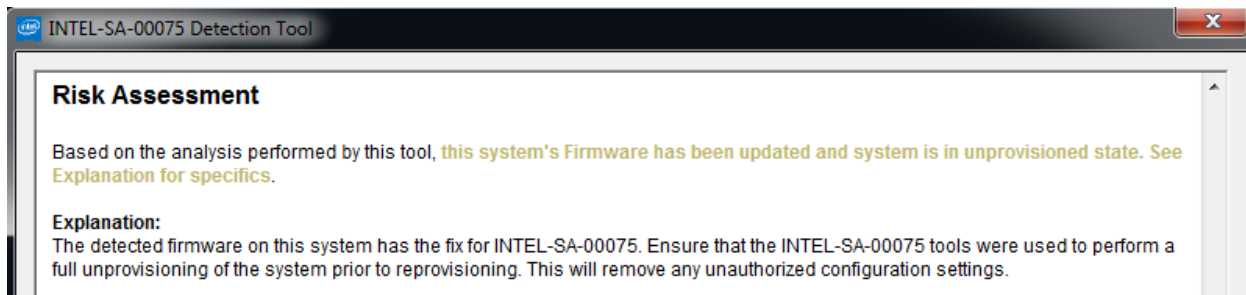
The Risk Assessment should state: “this system’s Firmware has been updated”; the Explanation should state: “The detected firmware on this system has the fix for INTEL-SA-00075”.

To ensure that the AMT vulnerability has been fixed, you may install and run the Intel-SA-00075 Discovery Tool utility. Double-click the **discoveryToolInstaller_1.0.1.39** file to install the Intel Discovery diagnostic tool. Follow installation prompts. When installation is complete, run the Intel-SA-00075 Discovery Tool.
